2023 Mission Ridge Expansion - Secondary Access Report

2023 Analysis of 5 Secondary Road Options to Mission Ridge Ski and Board Resort

MISSION RIDGE EXPANSION
SECONDARY ACCESS – REVIEW OF OPTIONS

SECONDARY ACCESS - CONCEPTS CHELAN COUNTY, WASHINGTON

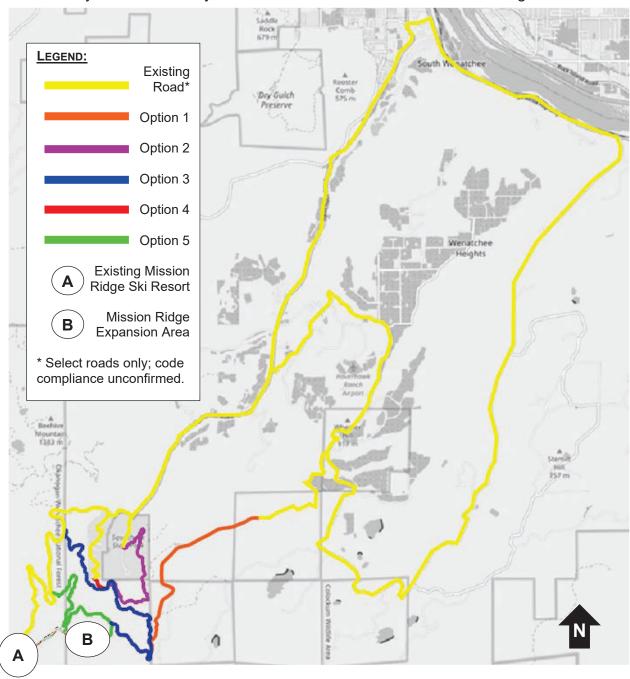
FIGURE 1: ILLUSTRATION OF SECONDARY ROAD OPTIONS
NOT TO SCALE

EcoSign has prepared a study, received December 15, 2022 (attached), identifying five routes that could provide secondary access for the MRE project area, together with commentary on the feasibility of these routes. Routes are illustrated in Figure 1 below.

In addition to these findings from EcoSign, we understand the intent of the secondary access is to maintain ingress and egress routes in the event one route is blocked. However, only Option 1 offers a separate and distinct route, the other four options merely create larger loops at the end of Squilchuck Road.

With Option 1, after 3.3 miles of new road, this route is shown to join an extension of Upper Wheeler Road on State-owned land. From that intersection down to Loop Road, the existing 1.65 miles of the road is unpaved and appears to involve at least one turn with an inside radius of less than 20 feet. Therefore, we find the route as presented in Option 1 would not achieve code compliance.

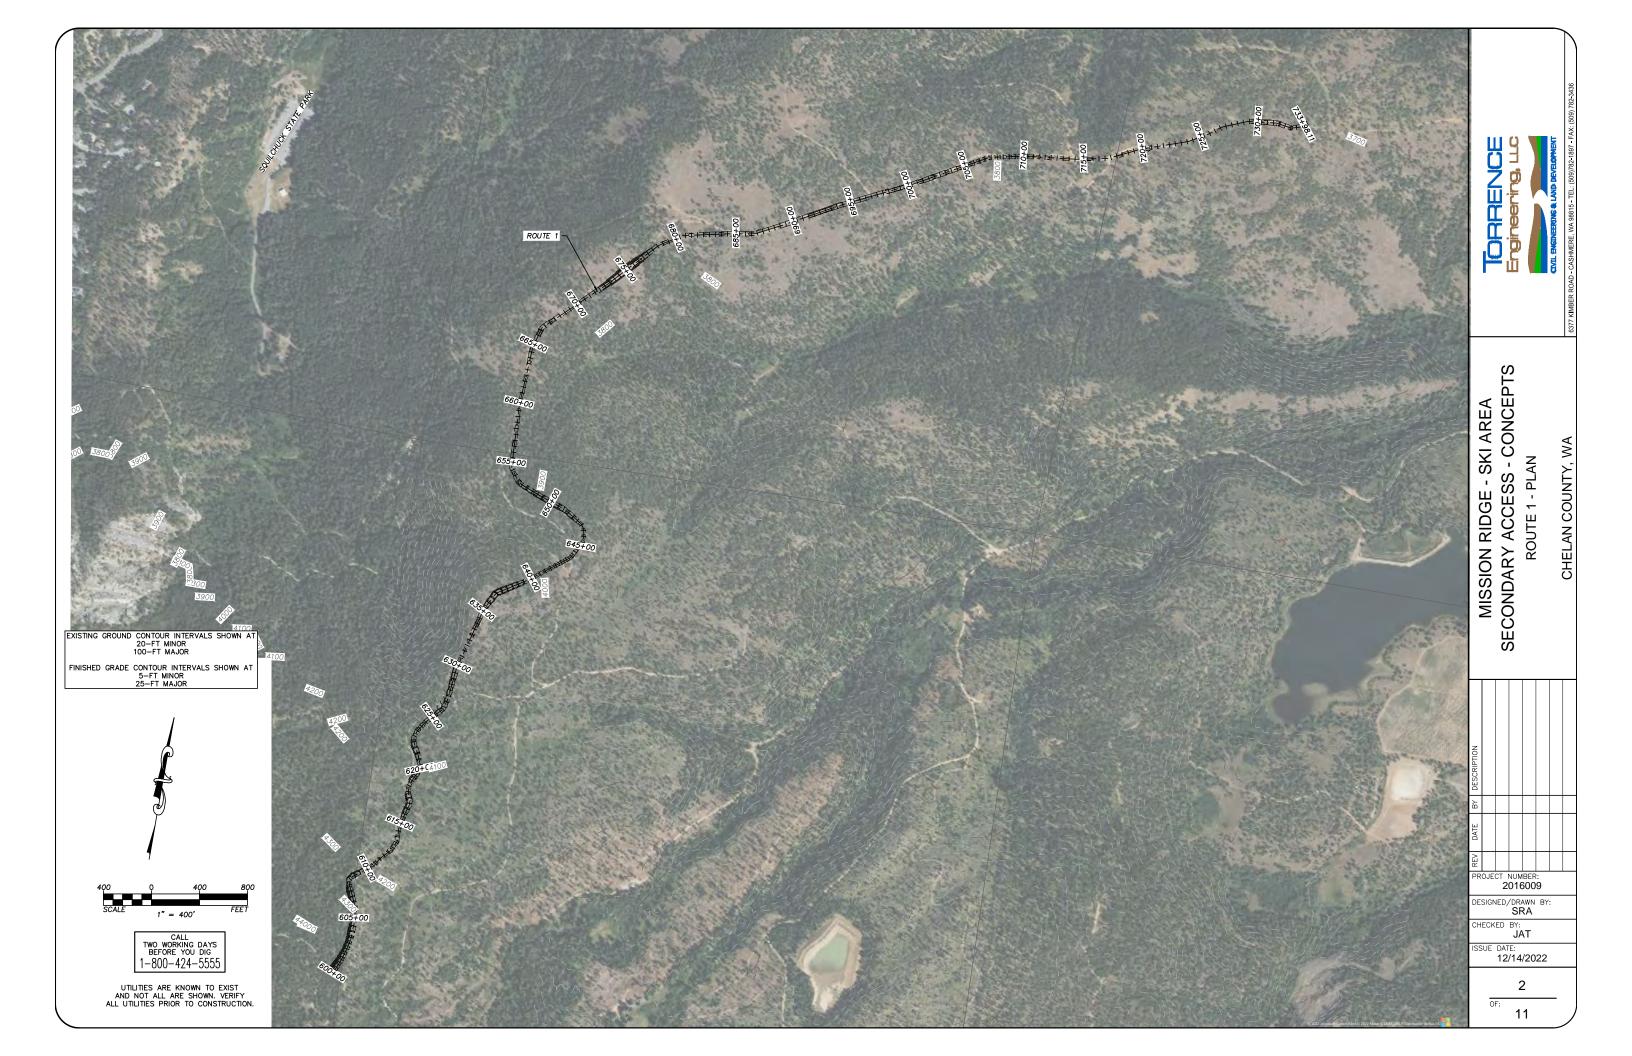
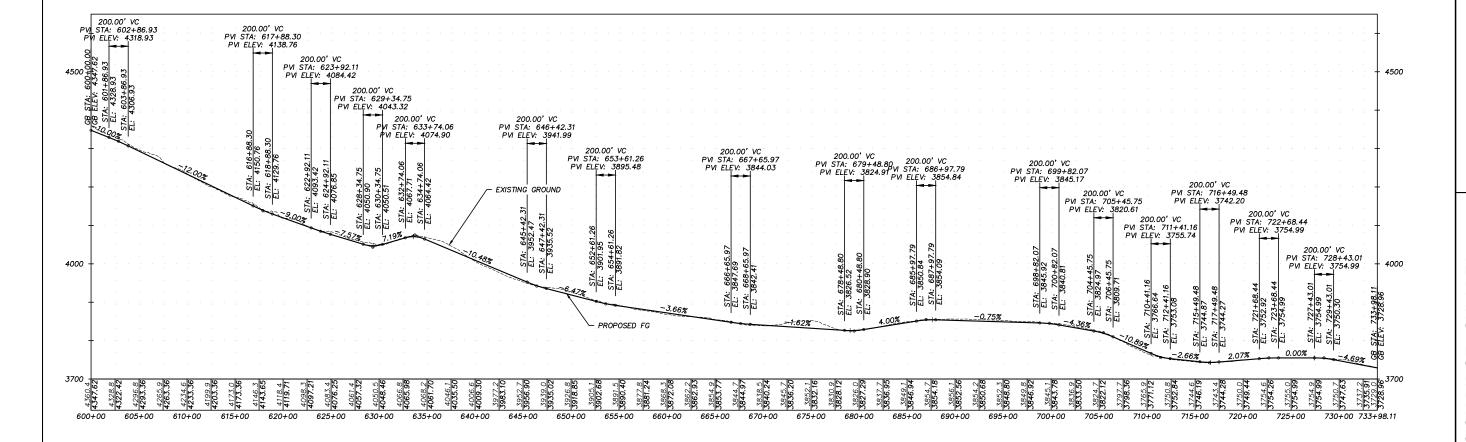
MISSION RIDGE - SKI AREA SECONDARY ACCESS - CONCEPTS **ROUTE 1 - PROFILE**

In general, the profile of Route Option 1 conforms to the design criteria. This route has a maximum slope of 12% and conforms to natural gradients. Since this profile conforms well to natural ground and avoids excessive steep grades, Ecosign rates the profile of Route Option 1 as Reasonable and Practical.

Route Option 1 requires total estimated earthworks of 69,453 yd³ cut and 9,927 yd³ fill, leaving a net surplus of 59,527 yd³ material to be trucked off-site. Due to the large excess of material to be removed from site, Ecosign rates the earthworks of Route Option 1 as <u>Unreasonable</u> and <u>Impractical</u>.

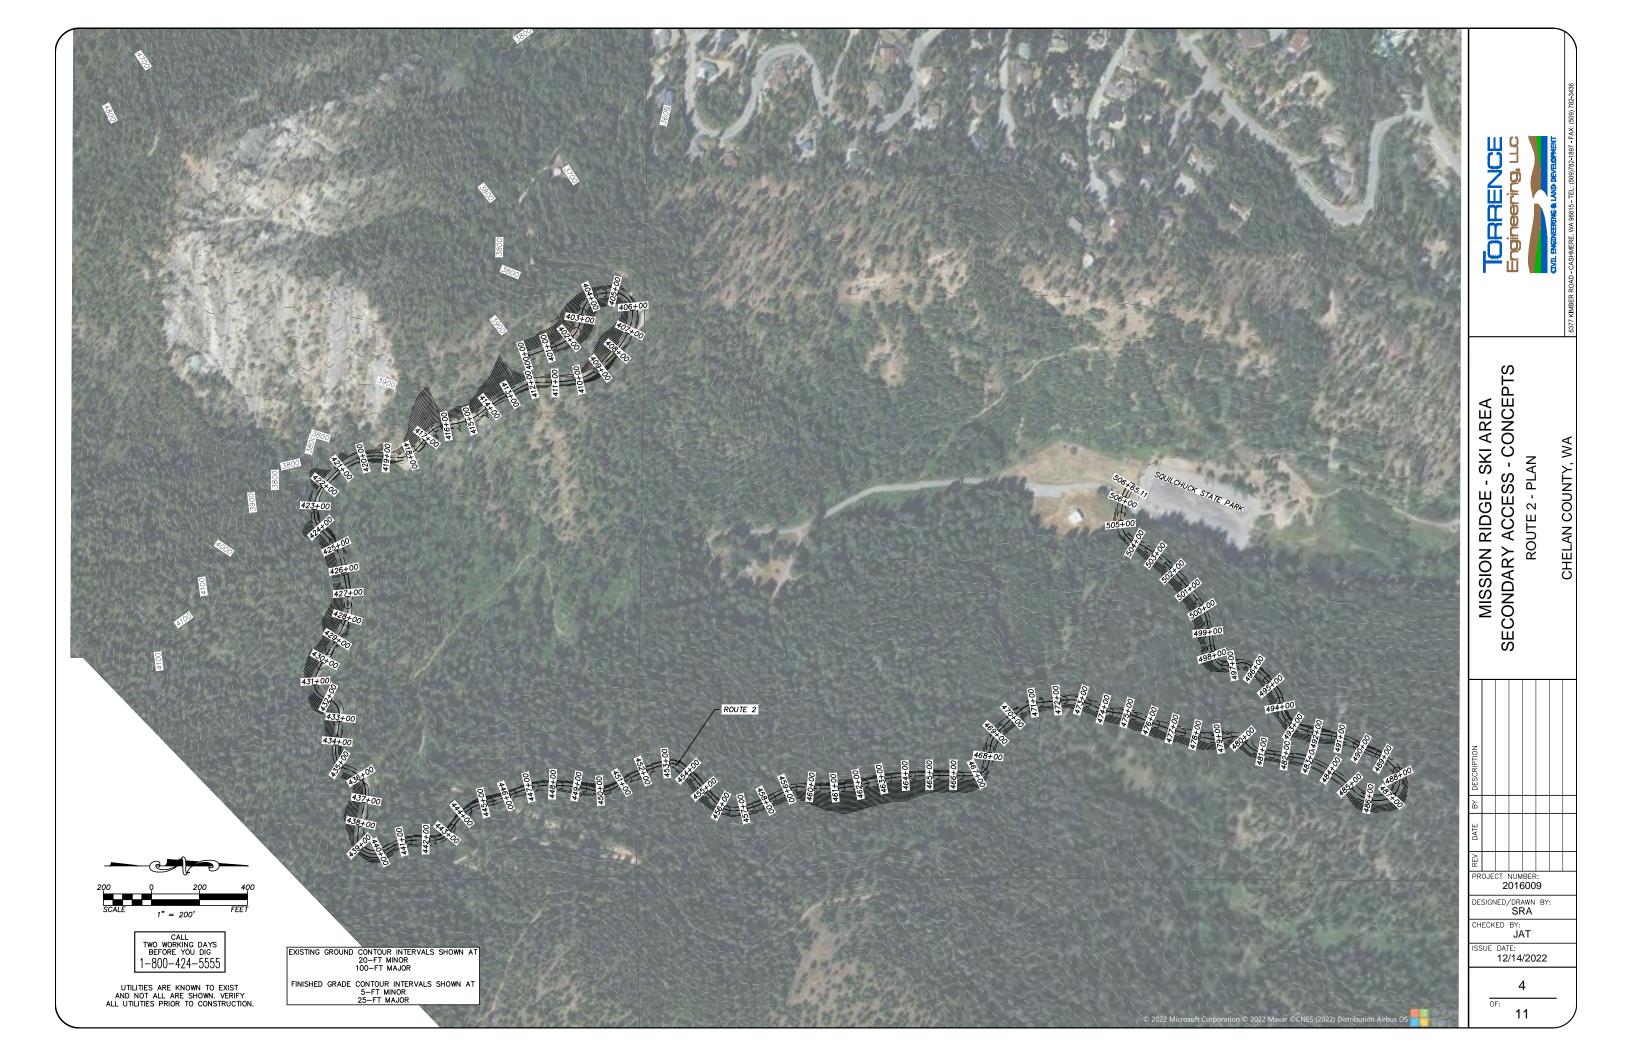
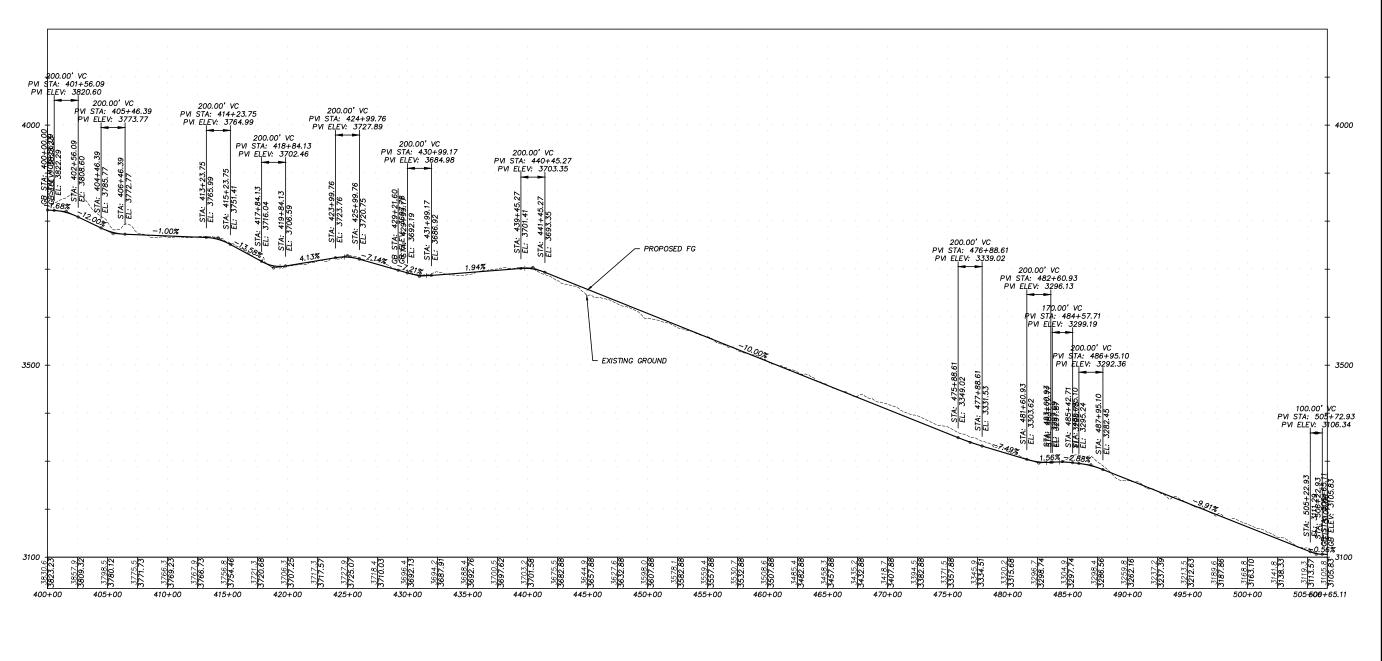
ROUTE 2 - PROFILE

In general, the profile of Route Option 2 conforms to the design criteria. This route has a maximum slope of 12% and conforms to natural gradients, except for some deep cuts at the switchback turn onto upper Route 3. Since this profile conforms mostly well to natural ground and avoids excessive steep grades, Ecosign rates the profile of Route Option 2 as Reasonable and Practical.

Route Option 2 requires total estimated earthworks of 188,375 yd³ cut and 23,707 yd³ fill, leaving a net surplus of 164,668 yd³ material to be trucked off-site. Due to the large cut volumes and excess of material to be removed from site, Ecosign rates the earthworks of Route Option 2 as <u>Unreasonable</u> and <u>Impractical</u>.

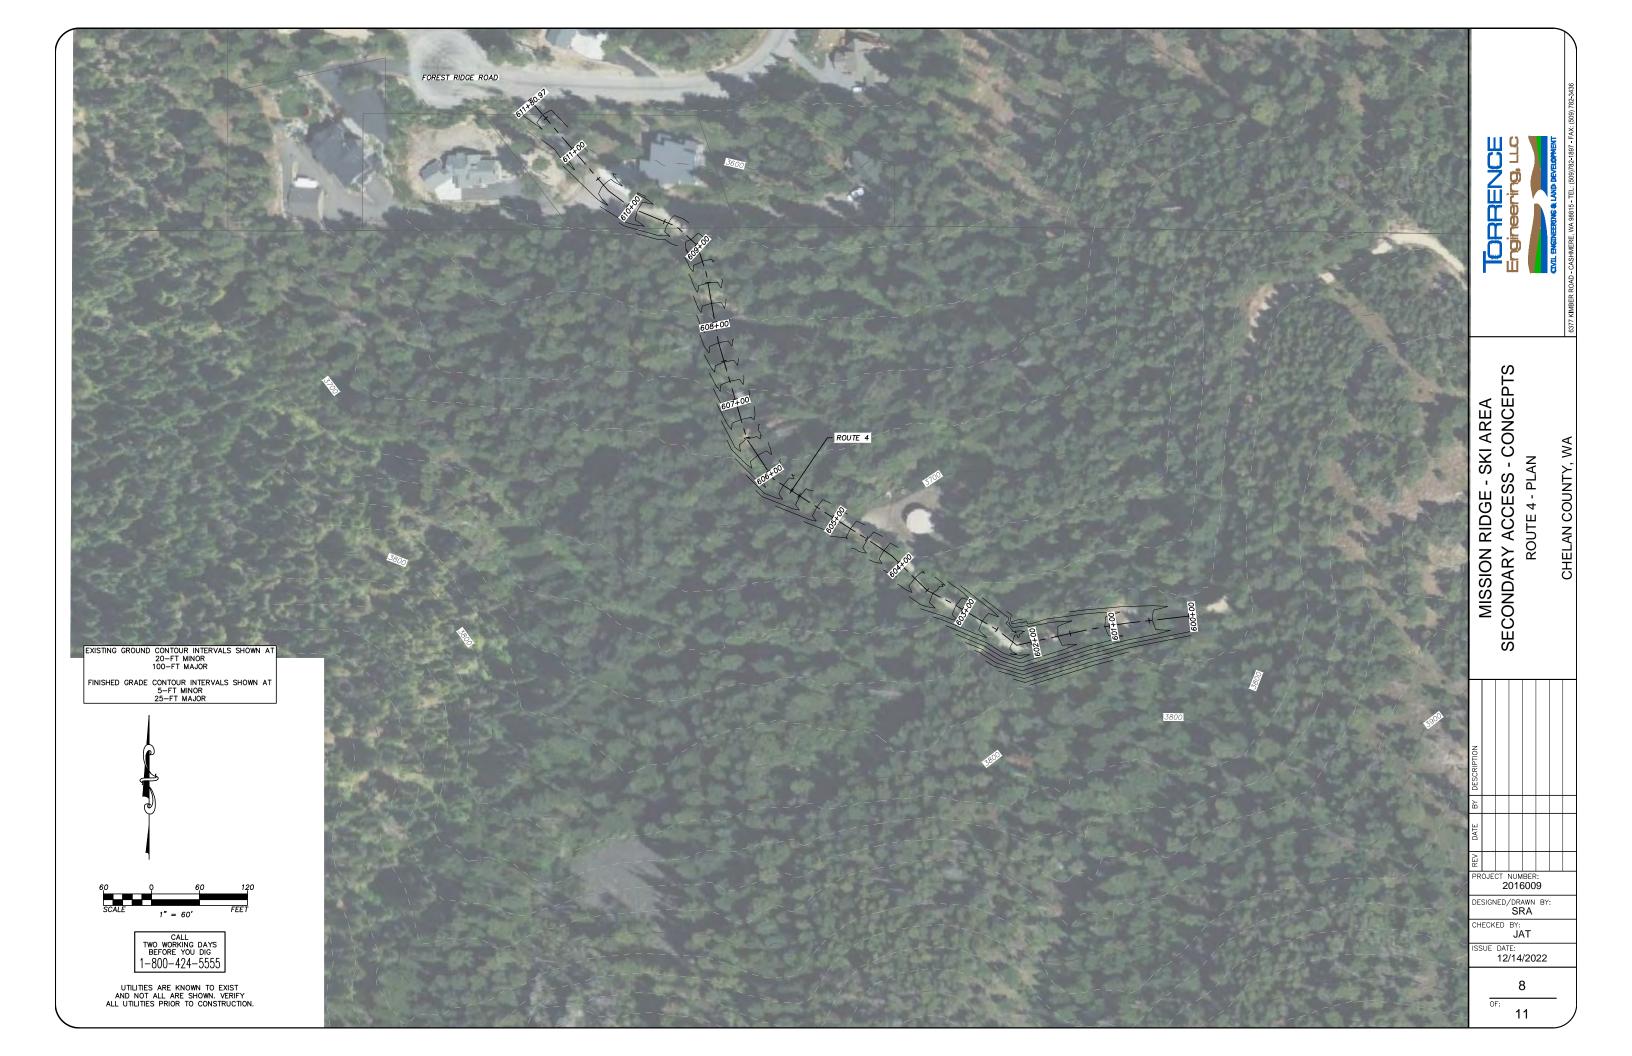
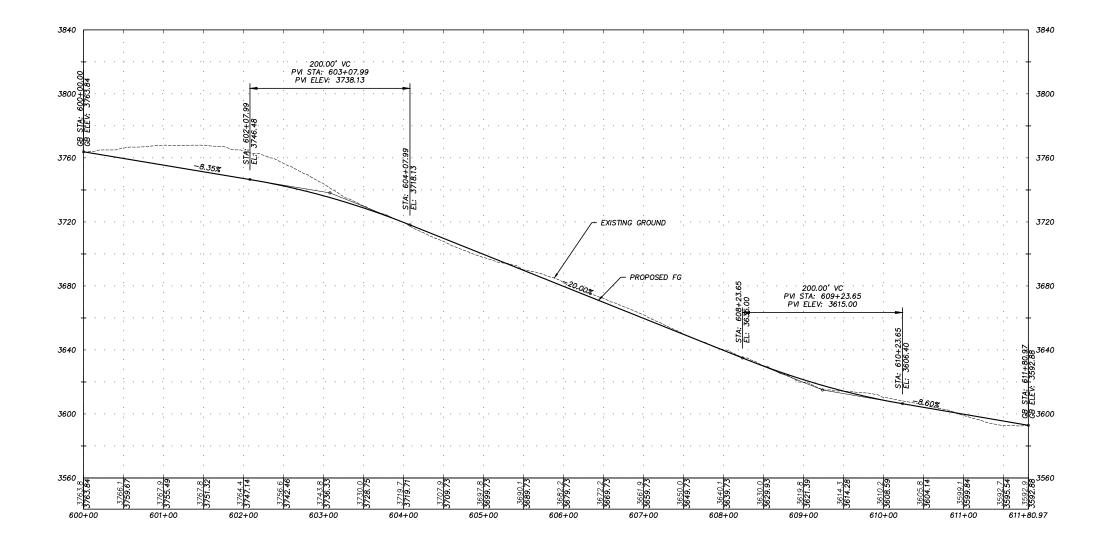
ROUTE 4 - PROFILE

The profile of Route Option 4 does not conform to the design criteria. This route has a maximum slope of 20% for ~700 ft length. Since this profile does not conform to the design criteria, Ecosign rates the profile of Route Option 4 as <u>Unreasonable</u> and <u>Impractical</u>.

Route Option 4 requires total estimated earthworks of 10,272 yd³ cut and 445 yd³ fill, leaving a net surplus of 9,927 yd³ material to be trucked off-site. In addition, approximately half of the earthworks for Route 3 will be required to reach the site. Due to the large cut volumes and excess of material to be removed from site, Ecosign rates the earthworks of Route Option 4 as <u>Unreasonable</u> and <u>Impractical</u>.
