**2024 Wetland Delineation and Stream Typing
Report for Mission Ridge**

Wetland Delineation and Stream Typing Report for Mission Ridge

September 2024

Address: 7500 Mission Ridge Rd, Wenatchee, WA 98801

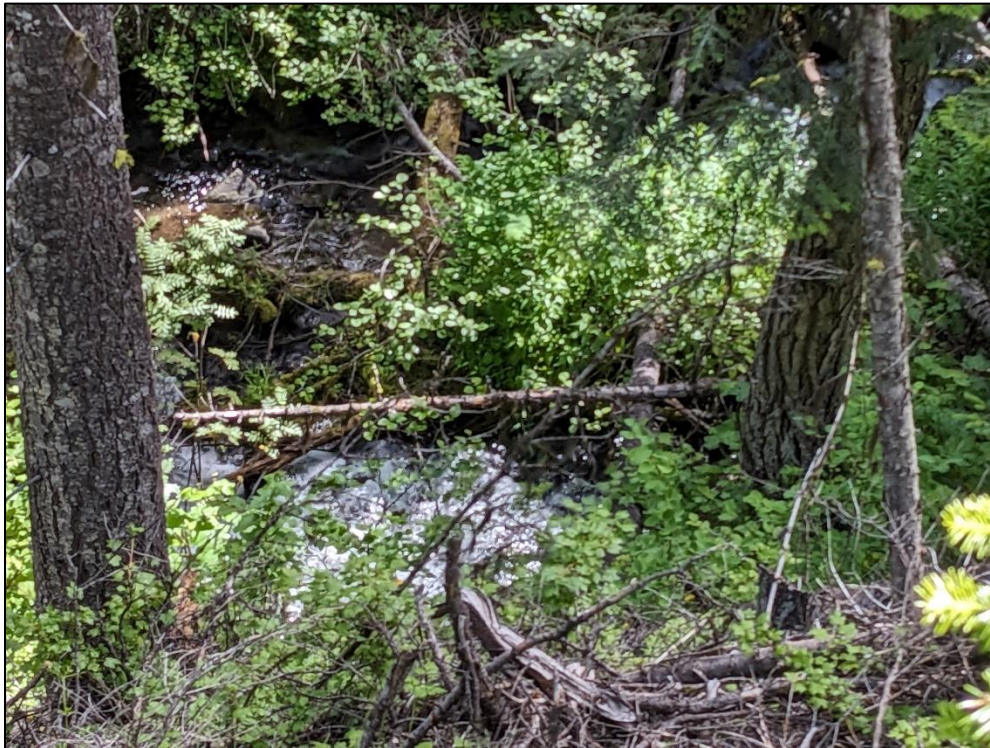
Figure 2. Squilchuck Creek.

The field form used to establish and describe the OHWM of Squilchuck Creek is included as Appendix B of this report. The creek runs in a very steep ravine with dense riparian vegetation and abundant downed trees and woody debris (Figure 2). Two gabion baskets are present in the creek near the south end of the study area, approximately 25 feet from one another (See Appendix A, Map 1, Point 3). The upstream basket has two corrugated plastic pipes, but water was flowing over the structure and not through the pipes (Figure 3). The WDFW SalmonScape database depicts these as “total fish passages barriers.” Two additional total fish barriers occur downstream of the study area before the creek drains to Miners Run Creek. No other instream structures were observed. The OHWM of Squilchuck Creek is clearly delineated throughout the study area by channel scour, clean boulders and cobble, bank erosion, exposed roots, and debris.

Squilchuck Creek is not a designated shoreline by Chelan County. It is a Type F stream where it flows within the study area. The State DNR hydrography database designates the on-site creek reaches as fish-bearing. The WDFW PHS database reports the occurrence/migration of rainbow trout (*Oncorhynchus mykiss*) in Squilchuck Creek. Salmonscape reports only an unspecified “all Salmonscape species” occurrence but does not indicate the presence of any individual salmon runs or species. The entire area is within the Evolutionarily Significant Unit (ESU) for Chinook and the Distinct Population Segment (DPS) for steelhead, although neither of these species actually occur in Squilchuck Creek.

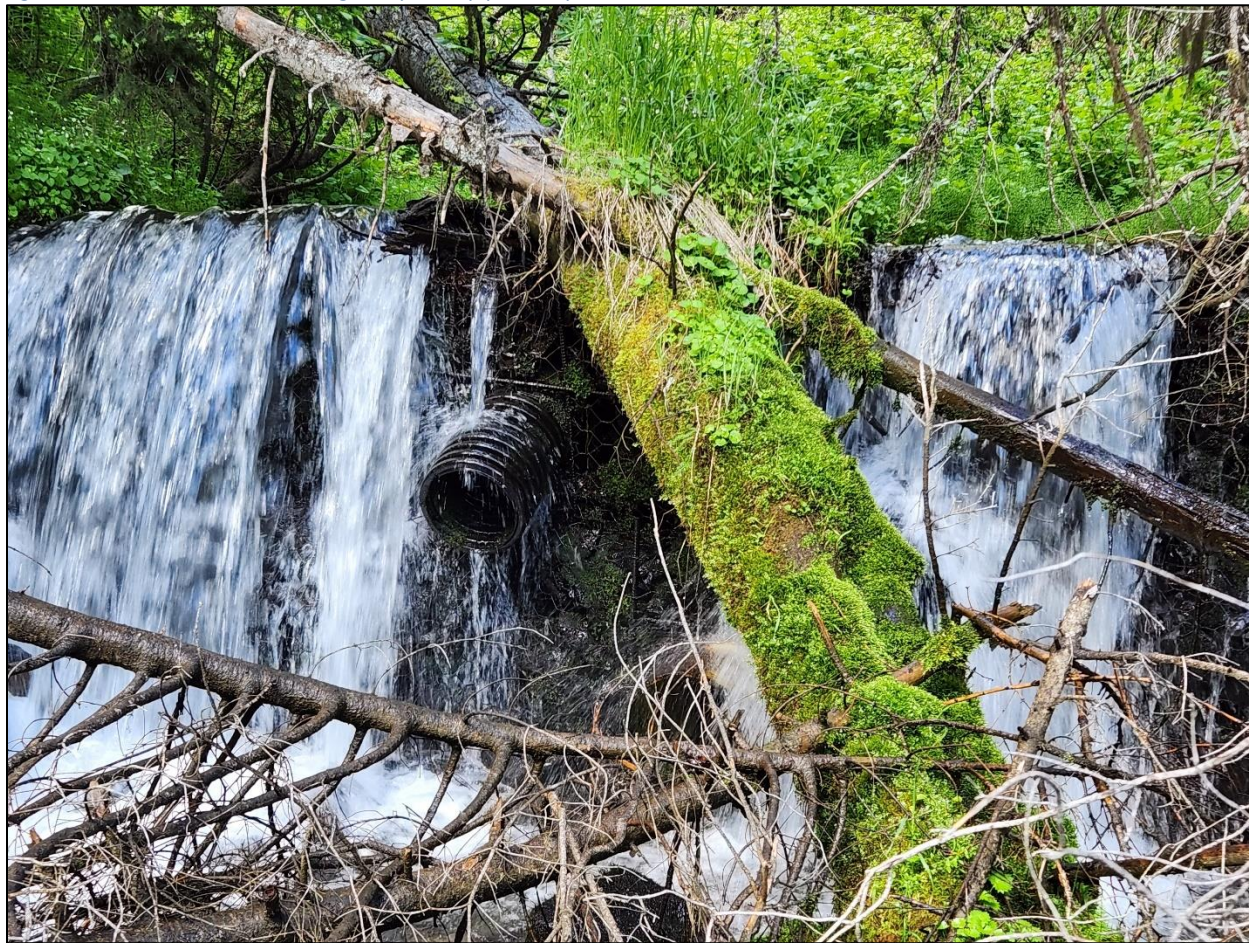
Figure 3. Gabion basket with corrugated plastic pipes in Squilchuck Creek.

Notably, most sources, including SalmonScape, PHS, NWI, the DNR Forest Practices Application Mapping Tool, and Chelan County GIS mapping depict Squilchuck Creek incorrectly throughout the study area. These sources show Squilchuck Creek draining directly into the wetland described in Section 4.2 (see, for example, Figures 6 and 8). This is in contrast to what was observed in the field as, depicted in Map 4, Appendix A. Squilchuck Creek is east of the wetland and no above-ground hydrologic connection was observed, despite high flows.

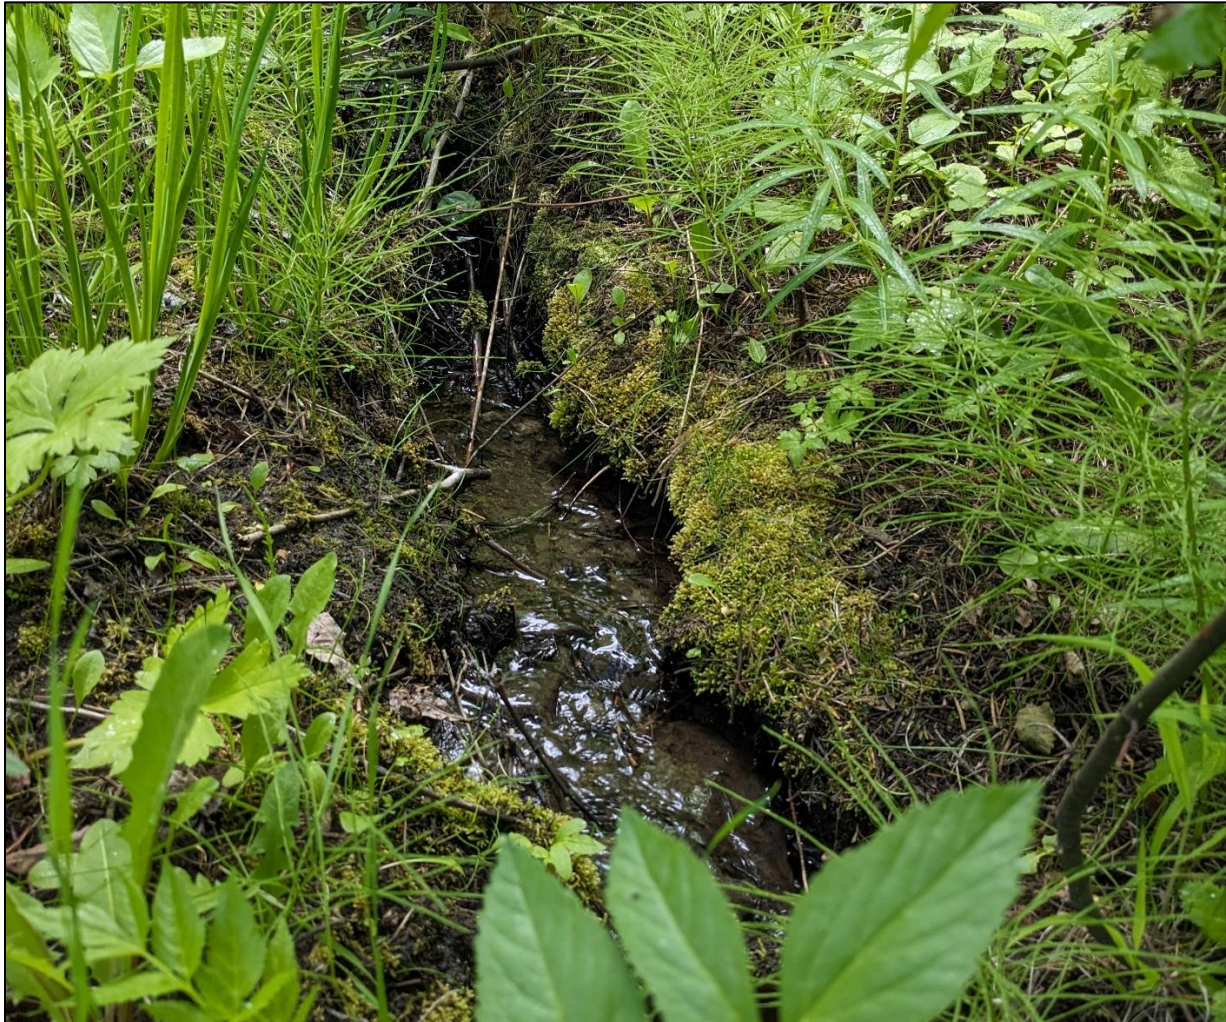
Figure 4. Stream A.

A second, unnamed stream is present in the study area and is referred to in this report as Stream A. It originates in a seep west of the corridor near Point 15 (see Appendix A, Map 2) approximately 1 mile north of the south corridor end and runs adjacent to or within the corridor for approximately 2,400 feet. The Stream A data points are labeled A through Q on Map 3 in Appendix A. The stream was flowing at the time of the June 28, 2004 site visit (Figure 4). The complete OHWM field form is included as Appendix C of this report. The OHWM is easily discernable by the lack of accumulation of sediment within the channel, the distinct bank along the channel, and the change in vegetation at OHWM. While the DNR and NWI databases depict tributary streams in topographic drainages along the Squilchuck, it is

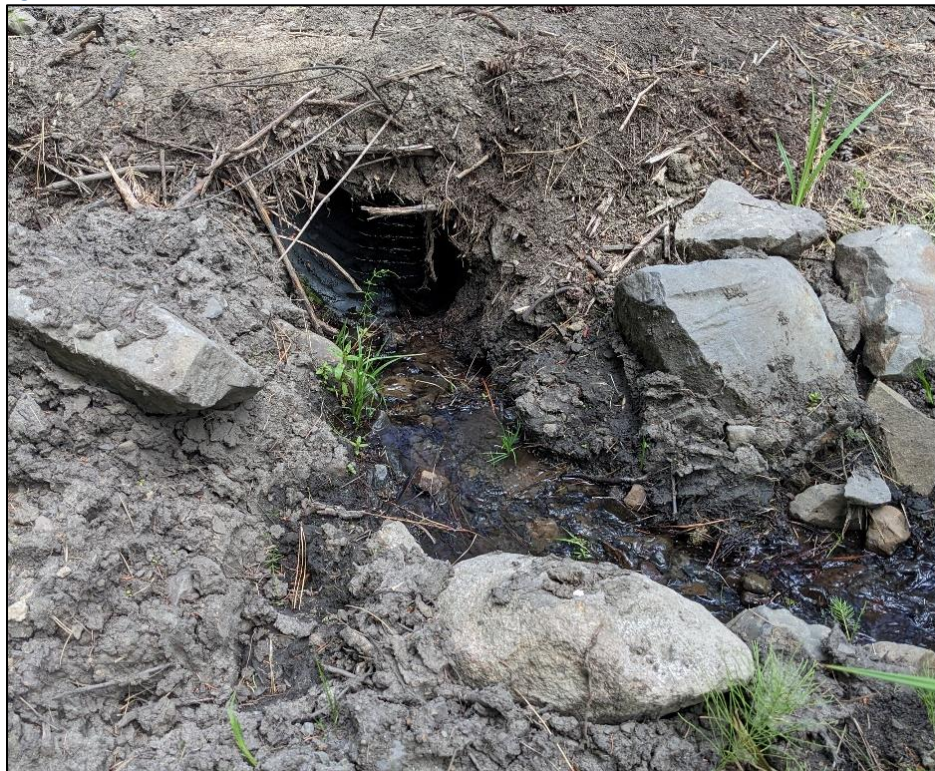
Figure 5. Stream A channeled to wetland.

Stream A splits just before entering a ponded wetland at the Scout-A-Vista camp near the north end of the corridor (see Section 4.2). A portion of the stream flows directly into the wetland and another portion runs north along a dirt road and then enters the wetland via a small culvert beneath a dirt road and what appears to be a manmade ditch lined by small boulders direct the water toward the pond (Figure 5). Aerial photographs spanning from 1998 to 2024 and taken from spring through autumn months show a largely consistent water level in the wetland pond. This, along with the NWI classification of Permanently Flooded (Section 4.2), implies that Stream A is permanently flowing and would be categorized as a type Np stream.

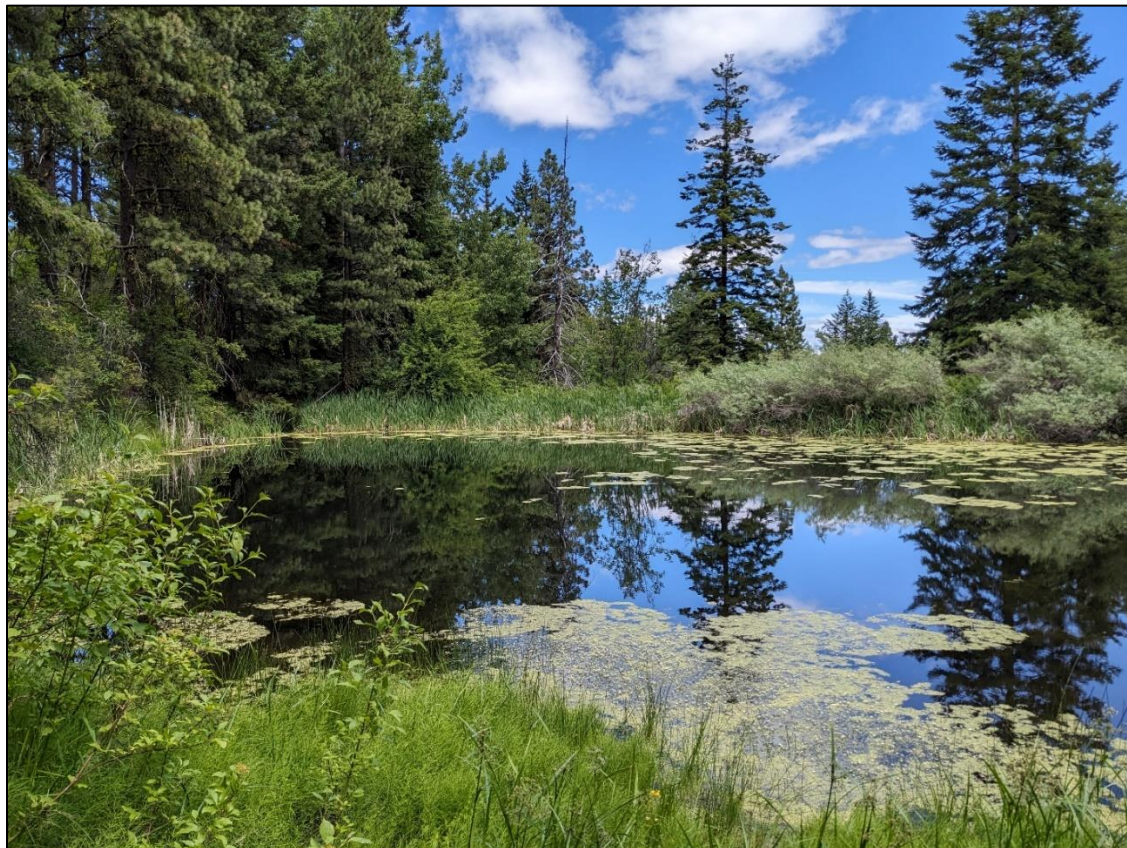
Figure 7. On-site wetland.

The on-site wetland is approximately 0.5 ac, the majority of which was ponded during the June 28 site visit (Figure 7); soils in the remainder of the area were saturated to the surface and the water table visible at 4-12 inches. Other Cowardin *et al.* (1979) classes in the wetland are shrub-scrub, emergent plants, and aquatic vegetation. The dominant woody species is coyote willow (*Salix exigua*), and herbaceous species include paniced bulrush (*Scirpus microcarpus*), cattail (*Typha latifolia*), and common spikerush (*Eleocharis palustris*). Duckweed (*Lemna minor*) is the predominant aquatic species.

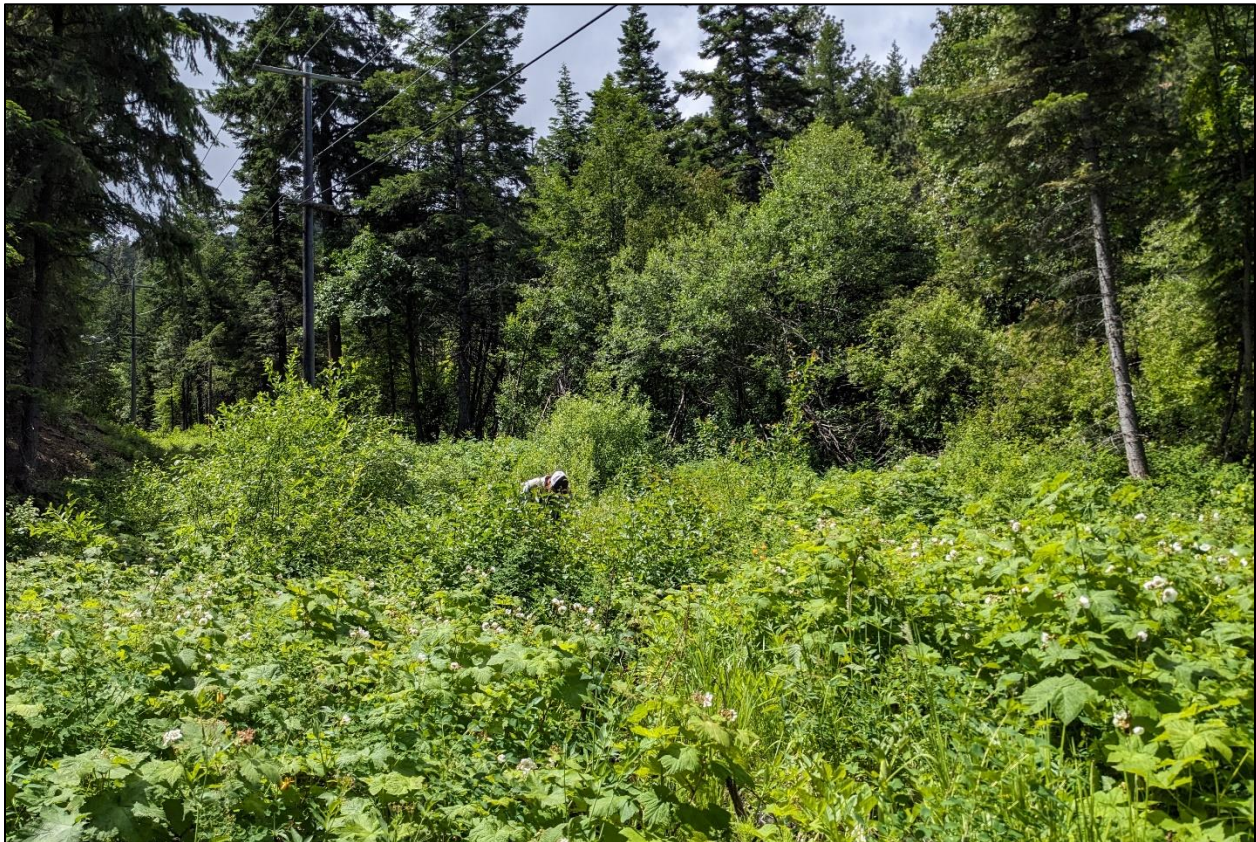
Figure 9. Maintained right-of-way beneath power poles.

Approximately one mile at the north end of the right-of-way (where power poles carry the electric utility line) is maintained in low woody and herbaceous vegetation (Figure 9). The remainder of the easement where the power utility line is buried is not maintained. See Table 2 for a full list of species observed during site visits.
